MARCH 19, 1997

BUILDING PERFORMANCE ASSESSMENT:

# *Hurricane Fran in North Carolina*

OBSERVATIONS, RECOMMENDATIONS,  
AND TECHNICAL GUIDANCE

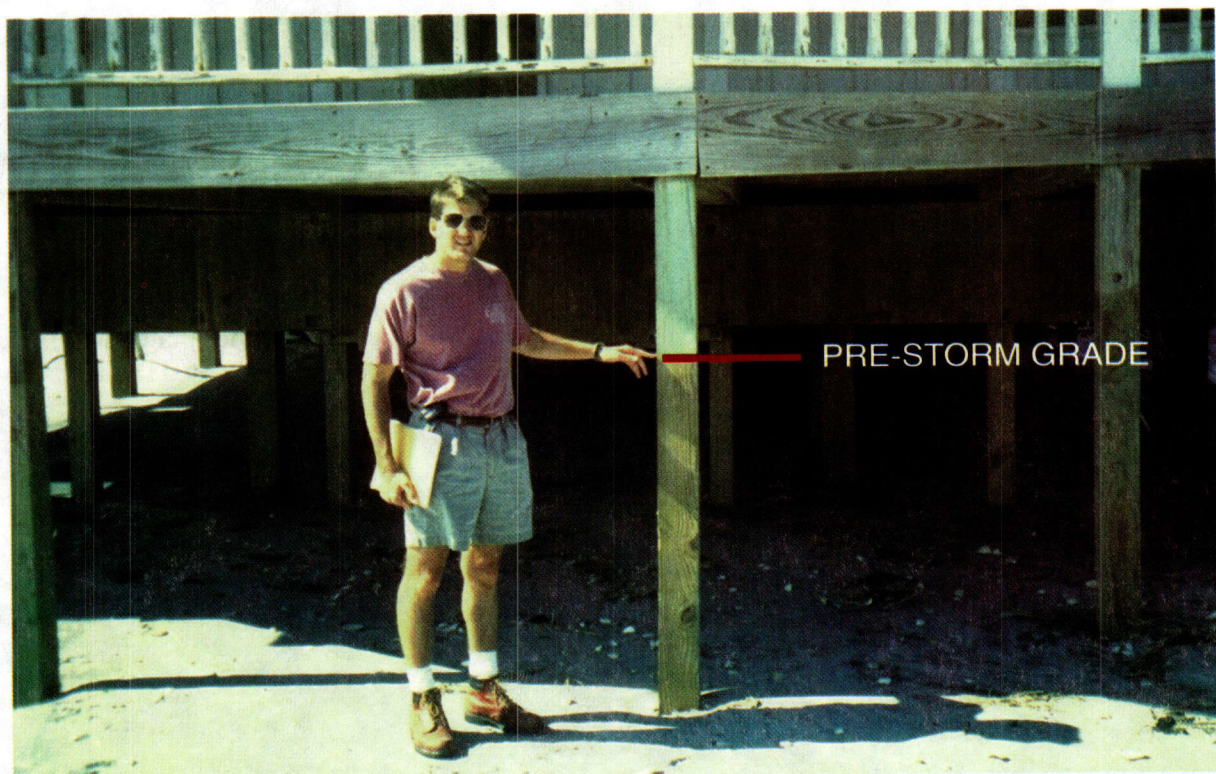
Figure 2-2      *Erosion resulted in significant loss of supporting sand, averaging 4 to 6 feet, under oceanfront buildings.*

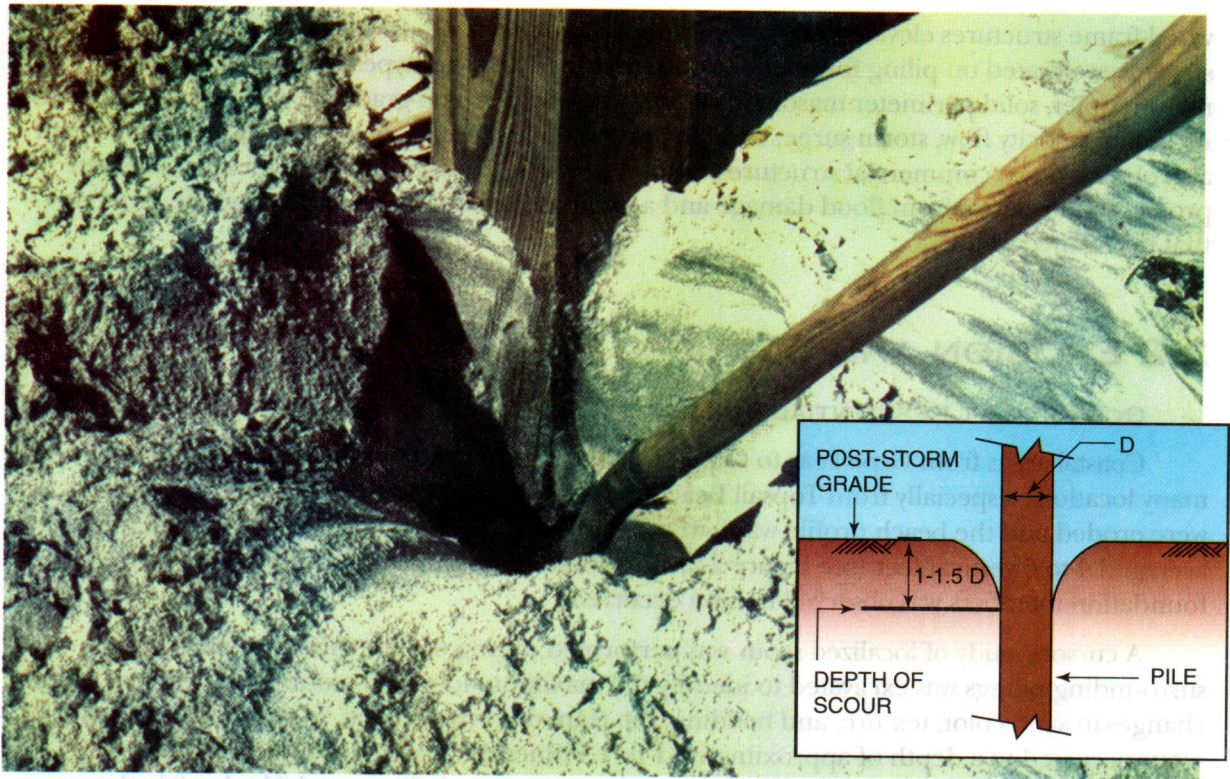
A cursory study of localized scour was performed during the site investigation. Sand surrounding pilings was excavated to identify the maximum localized scour that occurred. From changes in sand color, texture, and bedding, the team determined that, in general, localized scour occurred to a depth of approximately 1 to 1.5 times the diameter or width of the piling (see Figure 2-3). The depth of scour around 8-inch-diameter round pilings and 8-inch x 8-inch square pilings supporting oceanfront structures was measured to be approximately 10 to 11 inches.

Figure 2-3 Determination of localized scour from changes in sand color, texture, and bedding.

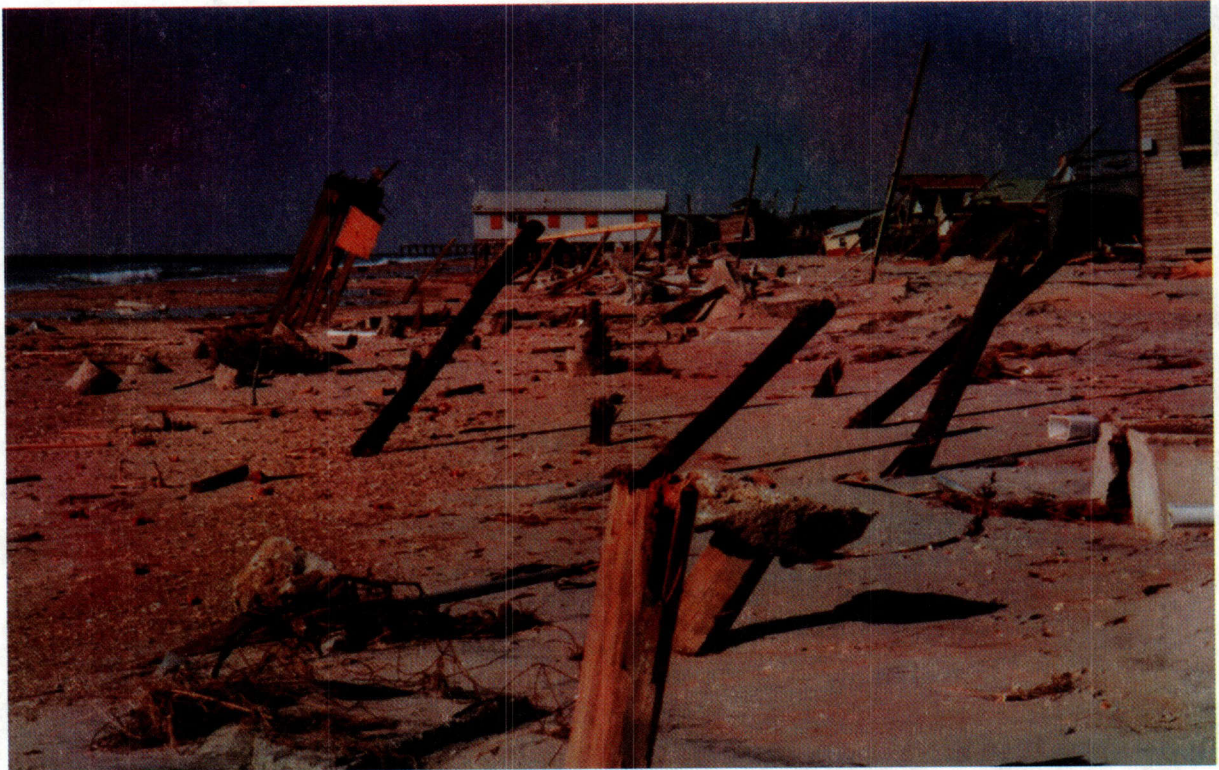
*Figure 2-4      Loss of the frontal dune and the resulting erosion and scour left many coastal houses unable to resist wind and flood loads acting simultaneously.*

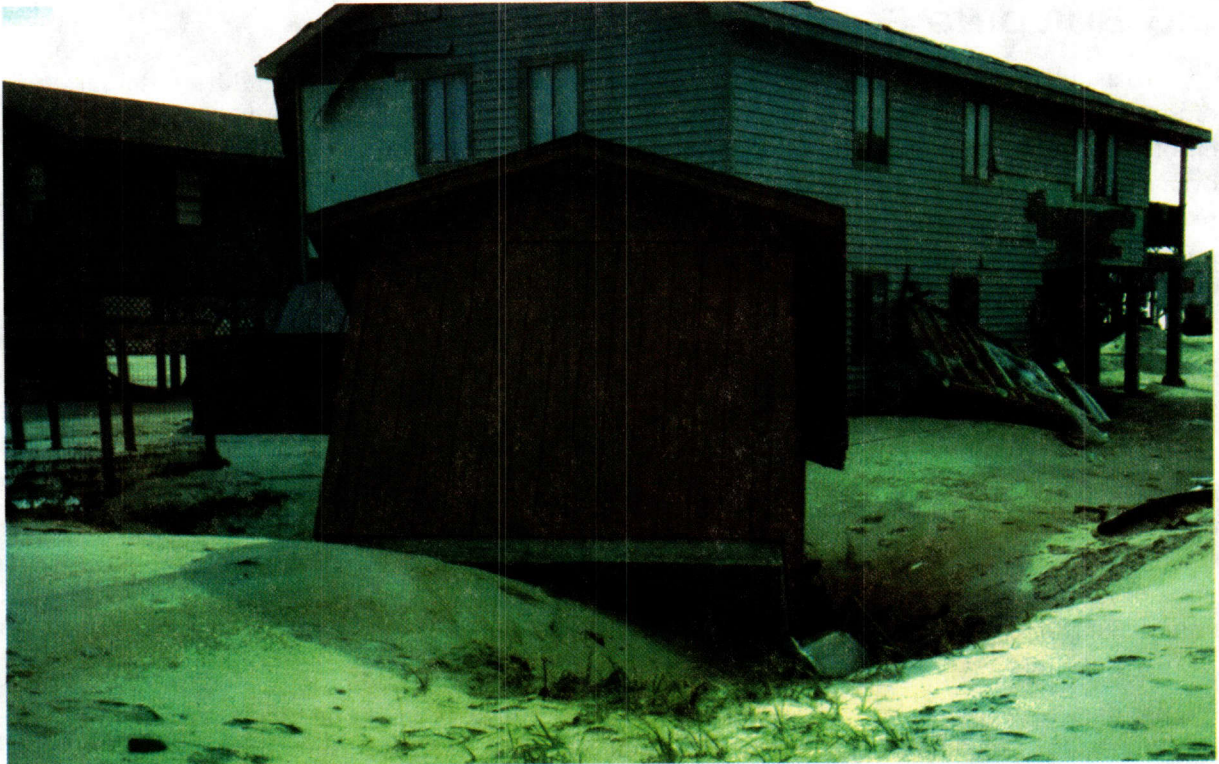
*Figure 2-5      Overwash of barrier islands generated high-velocity flows that caused extensive scour adjacent to large objects.*

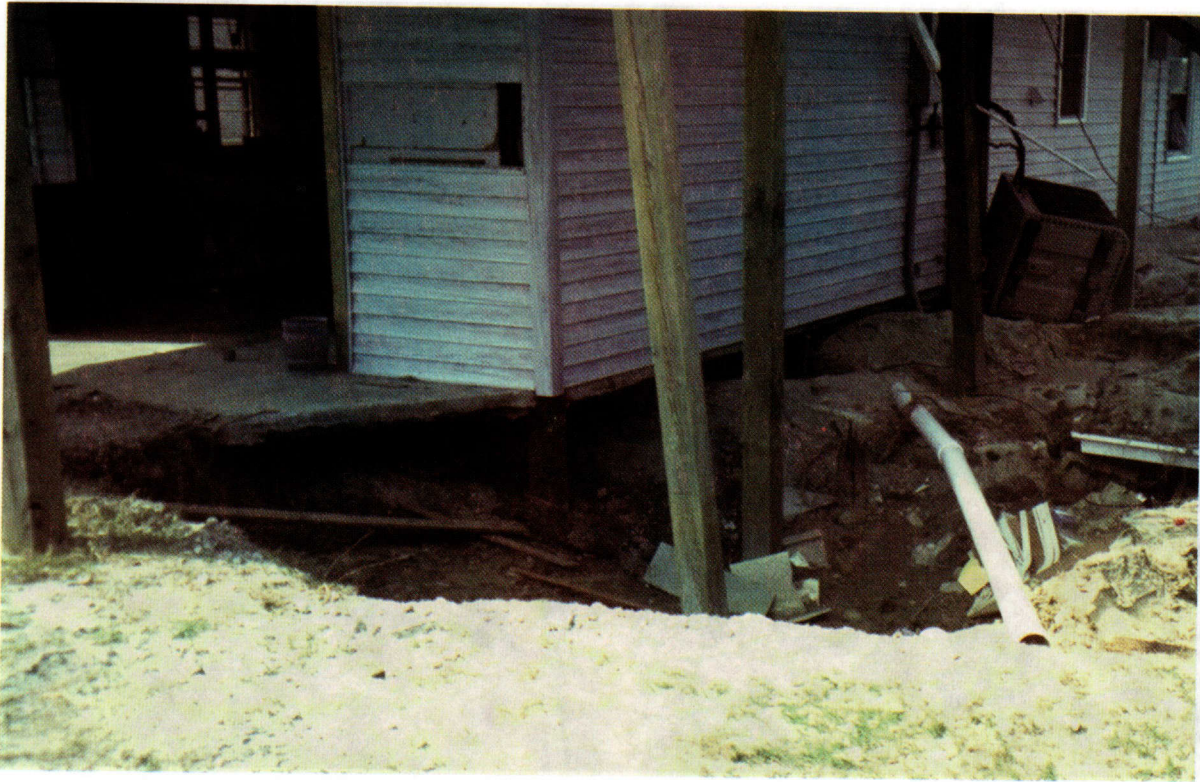
Figure 2-6      *The disruption of velocity flows by large, non-breakaway objects generated extensive scour that undermined vertical foundation members and slabs-on-grade.*

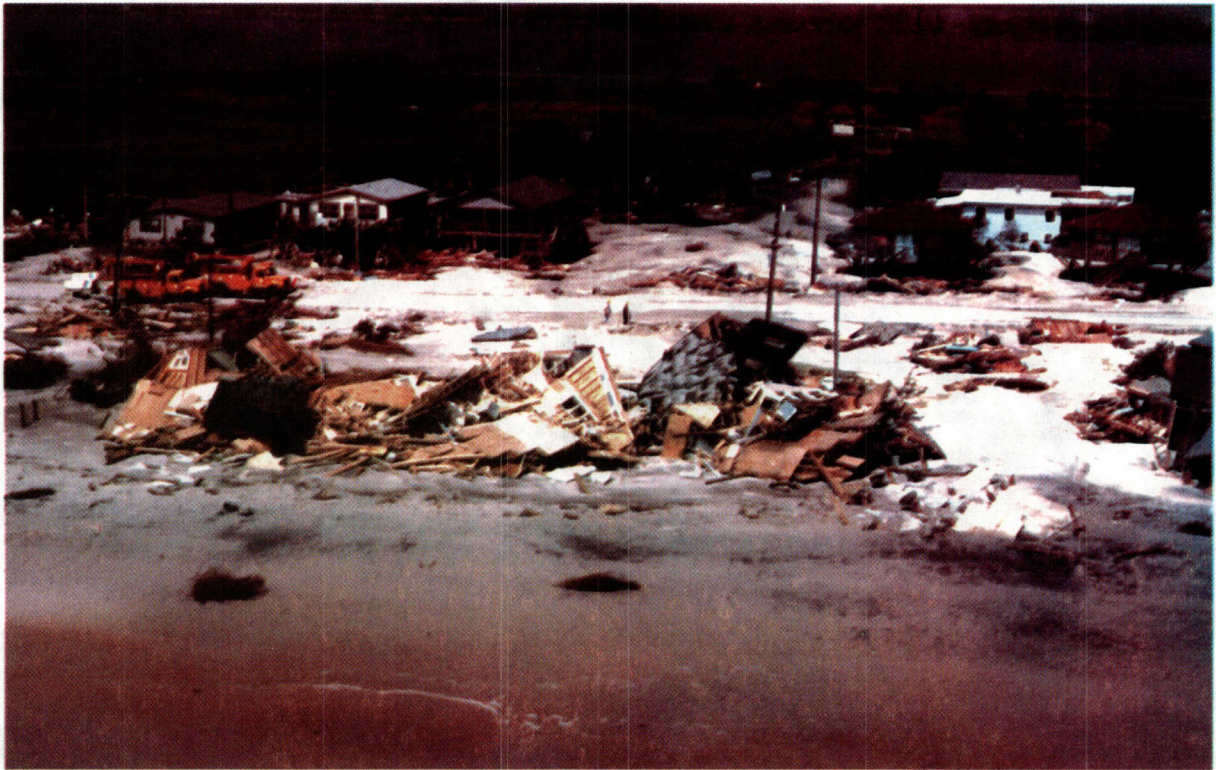
*Figure 2-7 Over 100 oceanfront houses were washed off their foundations or completely destroyed.*

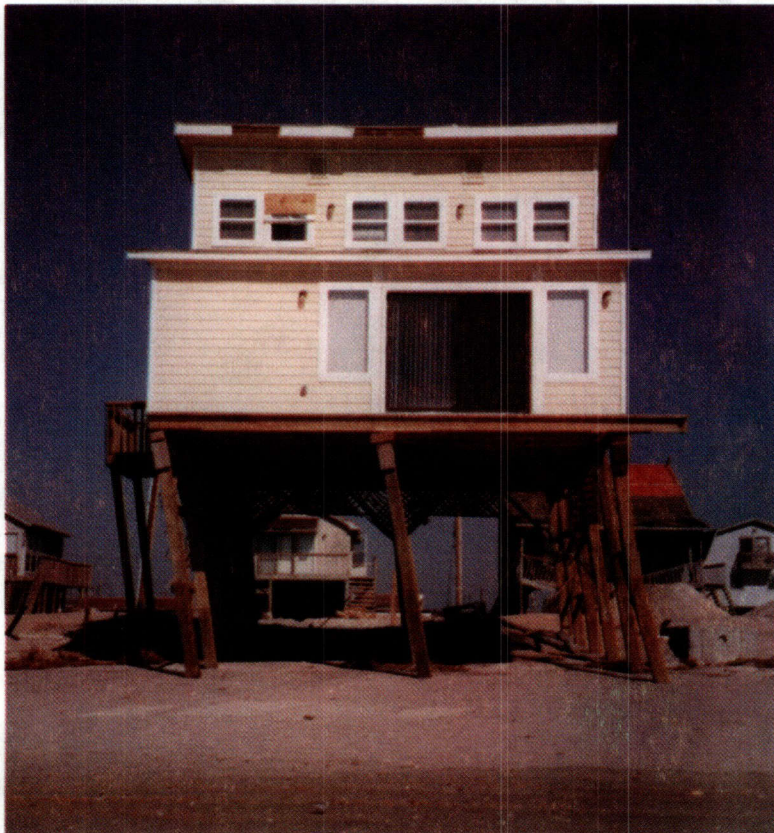
*Figure 2-8 Many oceanfront houses built prior to current (1986) North Carolina State Building Code requirements were found to be leaning or destroyed.*

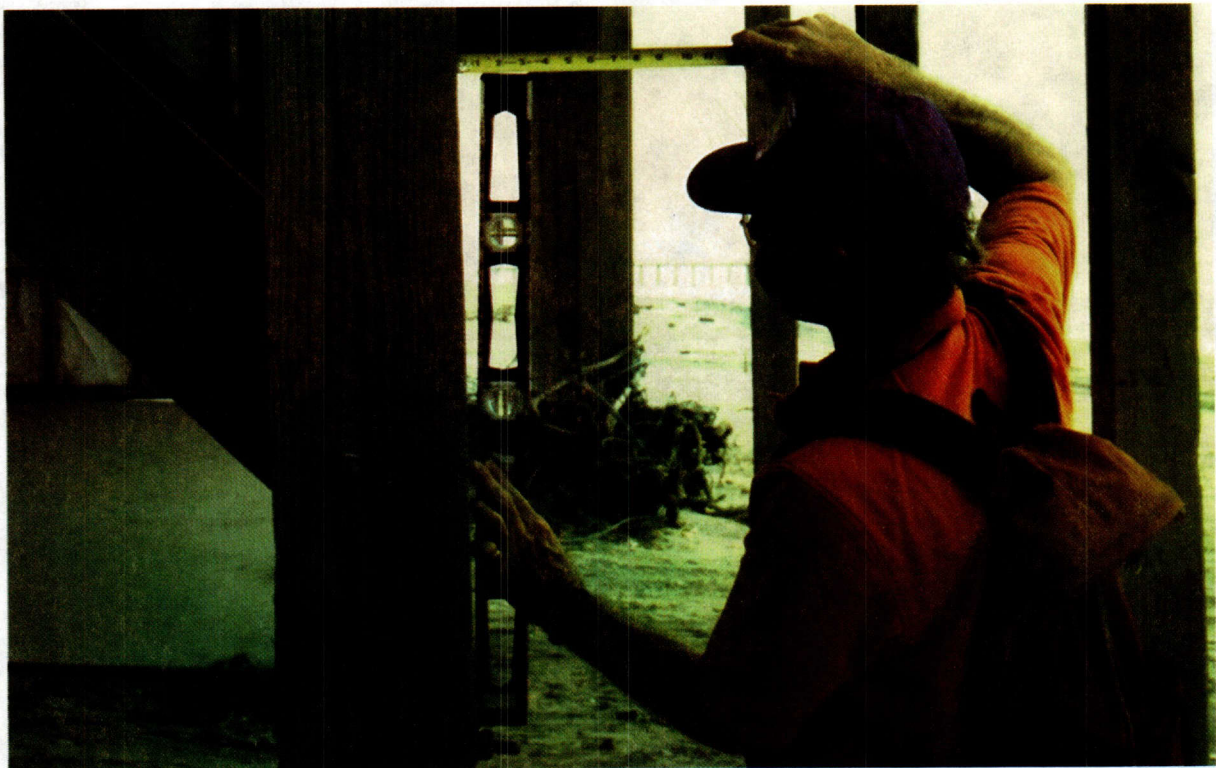
*Figure 2-10 One of several buildings observed to be leaning landward that were suspected of having been constructed to current North Carolina State Building Code requirements.*

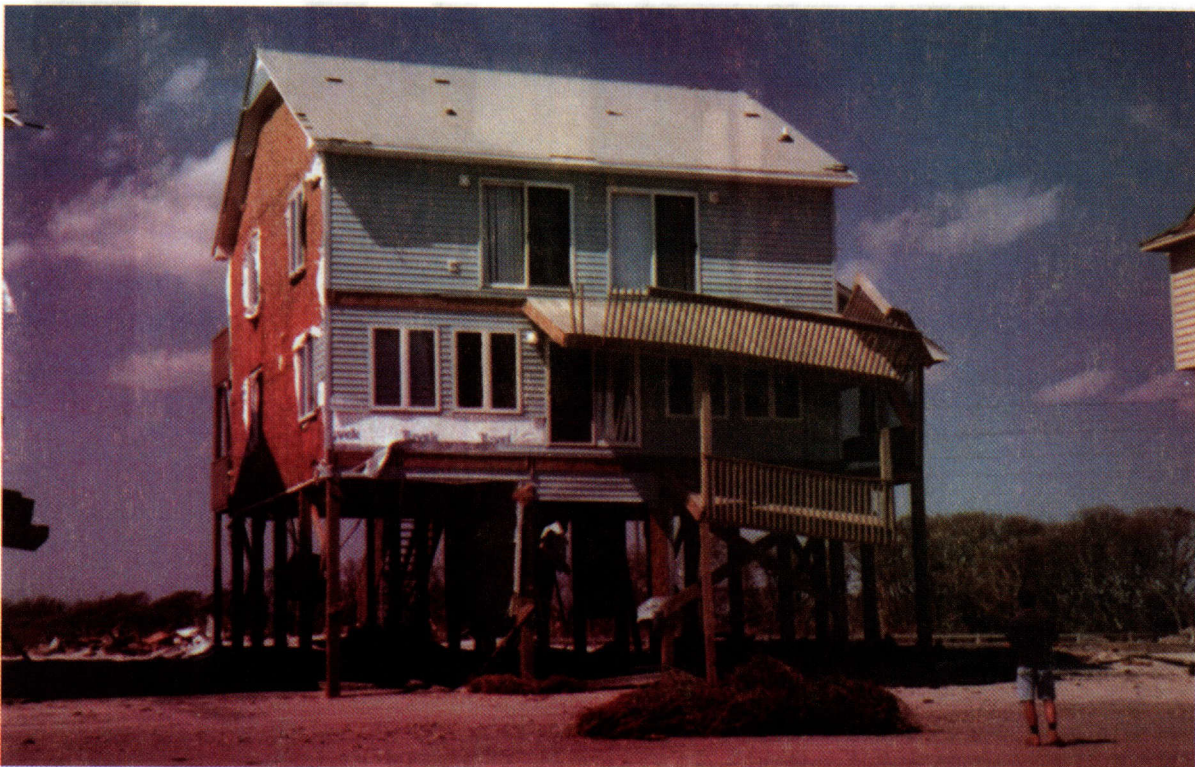
Figure 2-11 The BPAT observed several hundred decks and porches that collapsed as a result of insufficient foundation support.

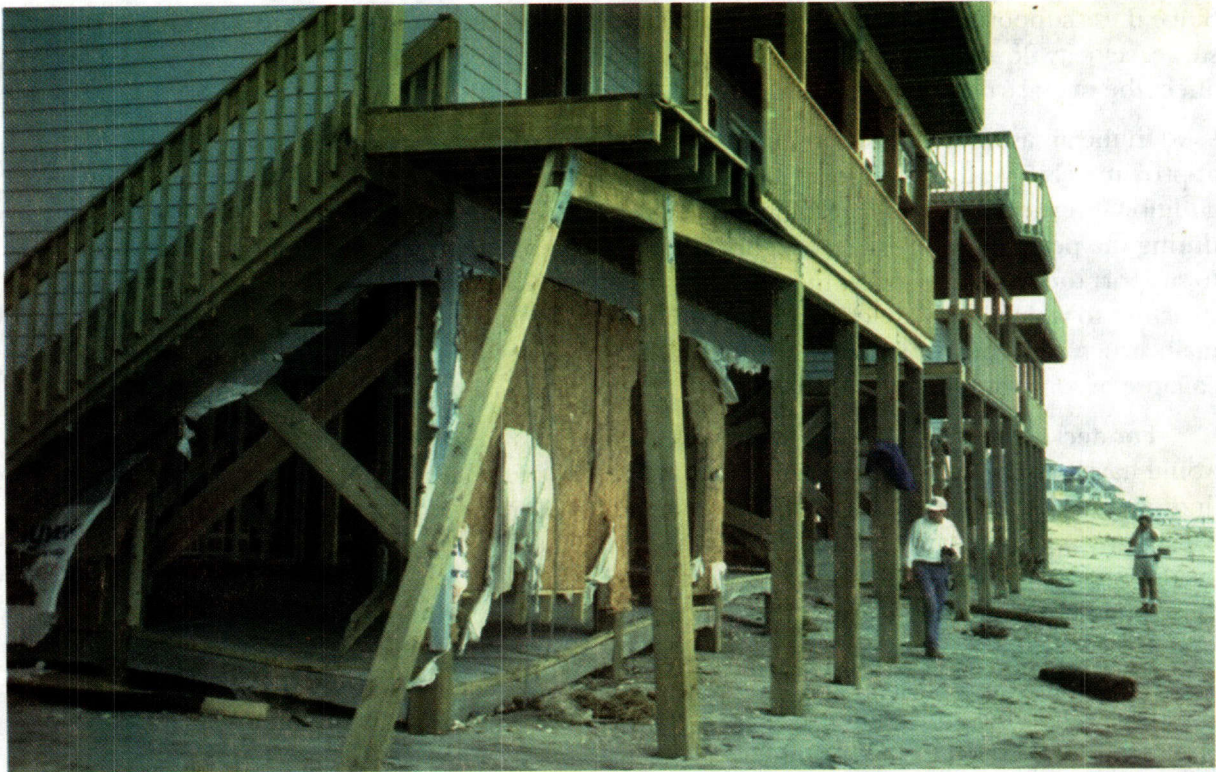
Figure 2-12 Example of building constructed to current North Carolina State Building Code requirements with insufficient embedment of piles/columns under two-story deck.

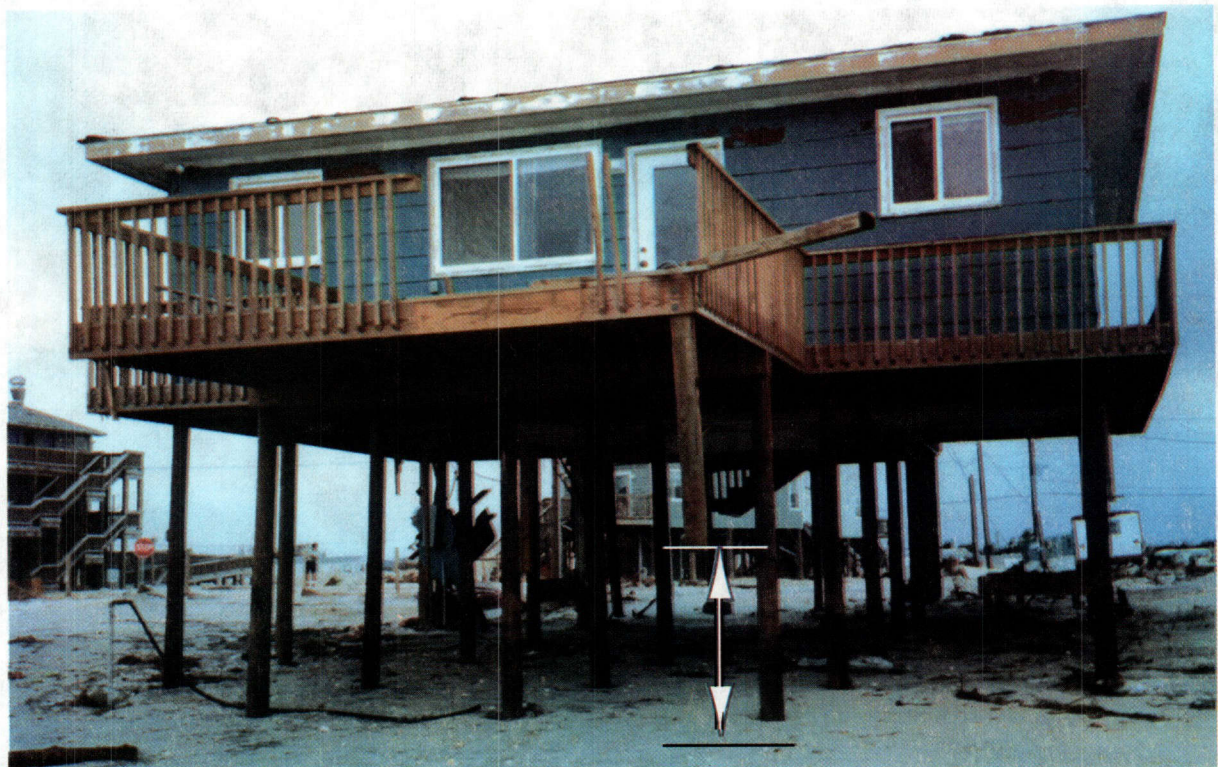
Figure 2-13 Embedment of deck supports into frontal dune was often shallow. After erosion of the dune, the bottom of the support for this deck was left several feet above grade.

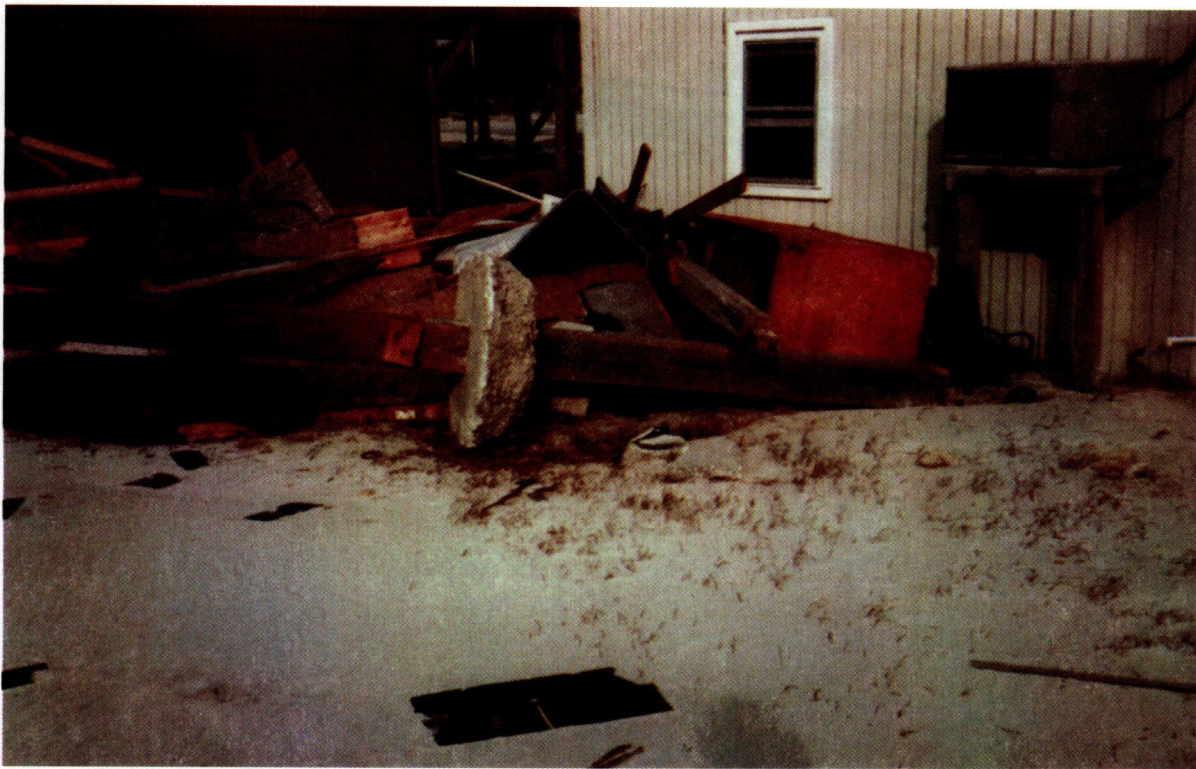
Figure 2-14 Storm-generated debris impacted nearby structure.

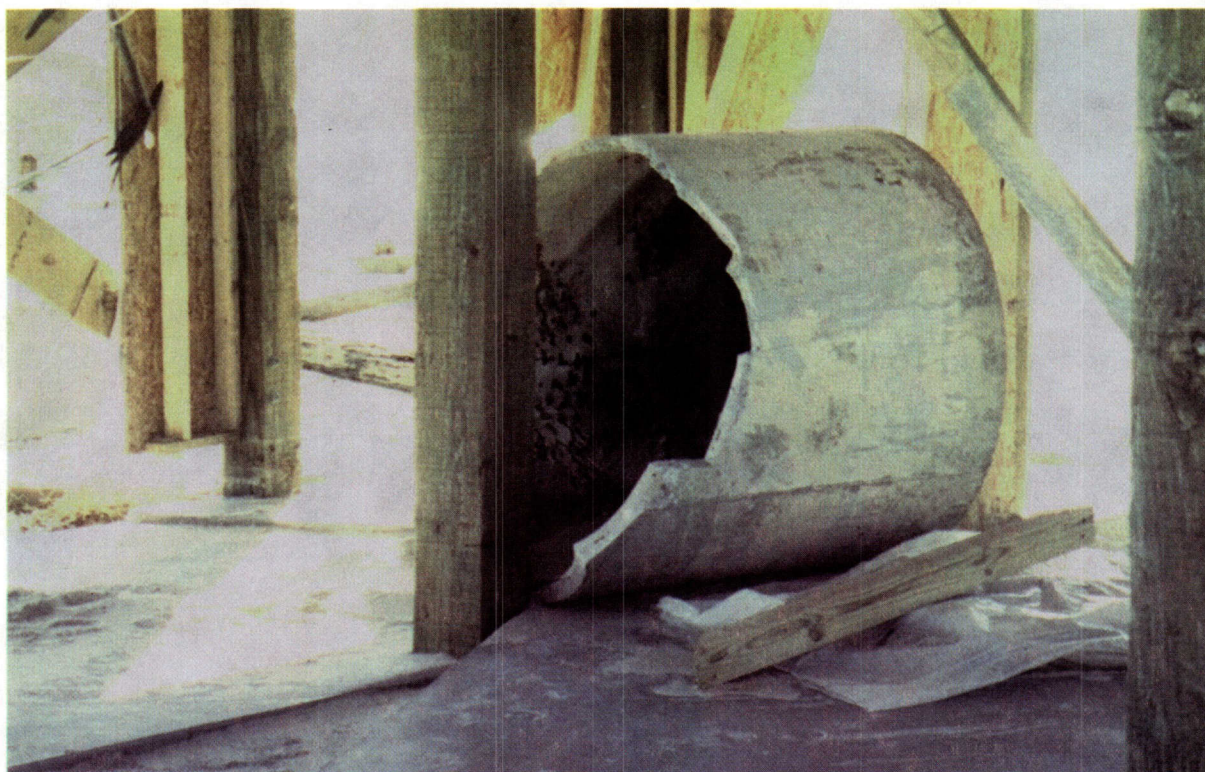
*Figure 2-17      Precast concrete ring section of septic tank became waterborne debris, impacting building foundation members.*

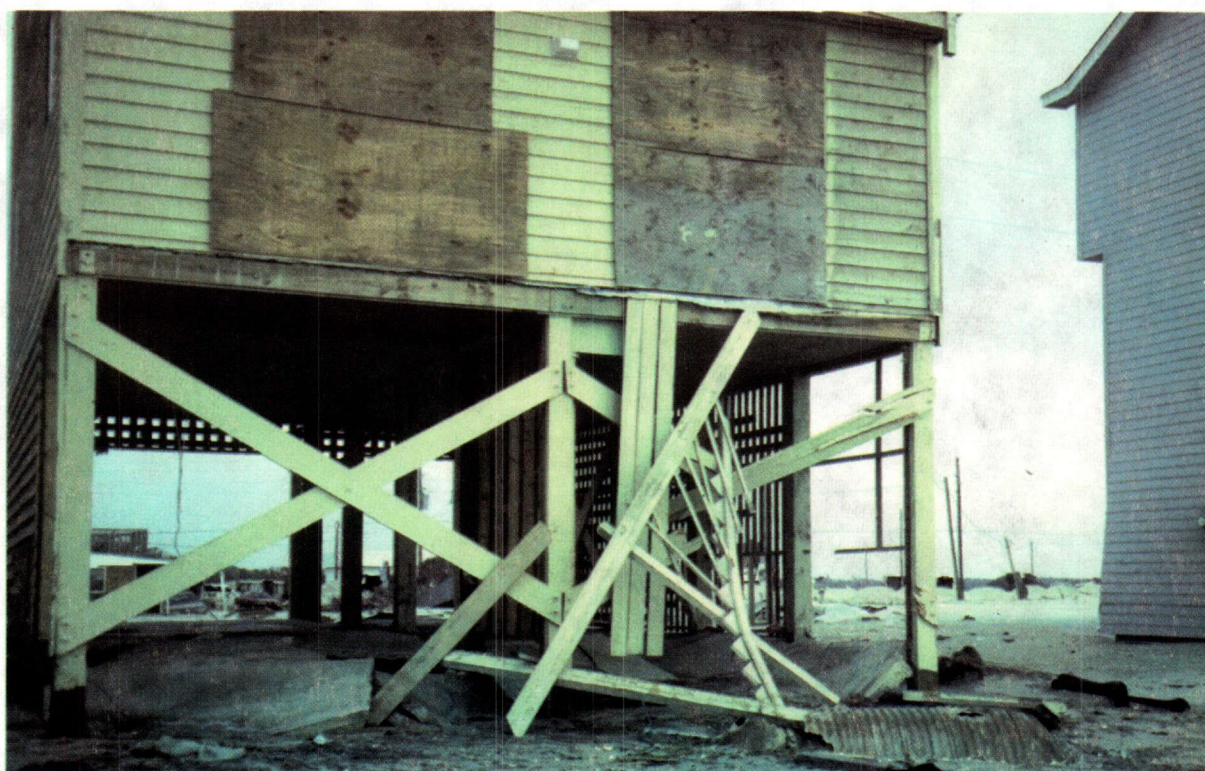
*Figure 2-18      Impact of debris from a damaged deck appeared to have broken cross-bracing.*

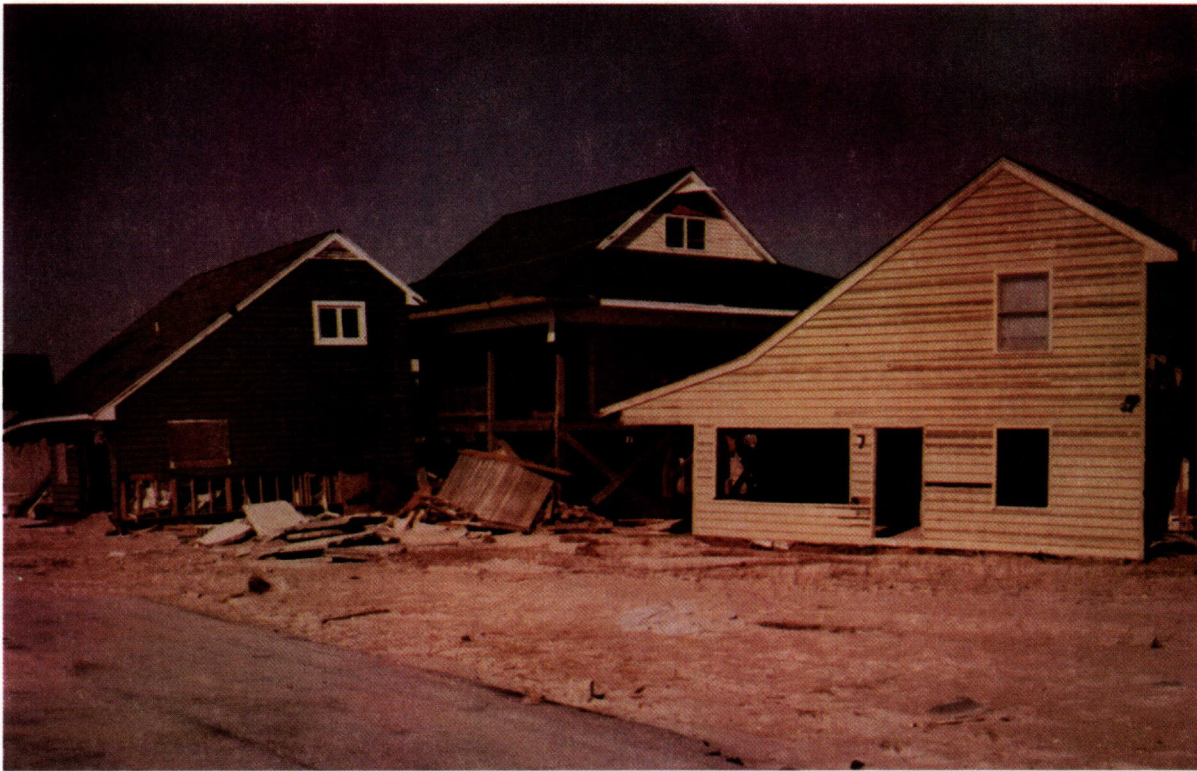
Figure 2-19 Example of extreme impact — two houses floated and pushed into another house.

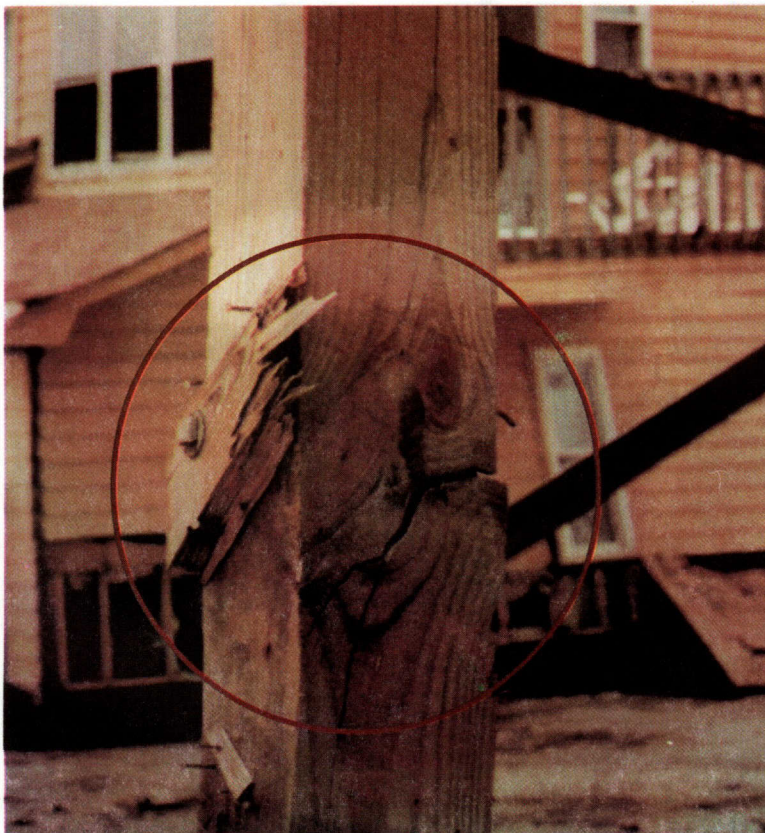
To resist coastal flood forces, timber pilings depend largely on their dimensions and depth of embedment, but another important factor is the grade of lumber used. Lower grades of lumber may have knots, cracks, or other imperfections that contribute to failure when the piling is acted on by water and debris impact forces. For example, Figure 2-20 shows a failed timber

Figure 2-20  
Example of broken piling. The piling broke at the location of several knots (circle), where cross-bracing was attached (note remaining bolt and piece of bracing).

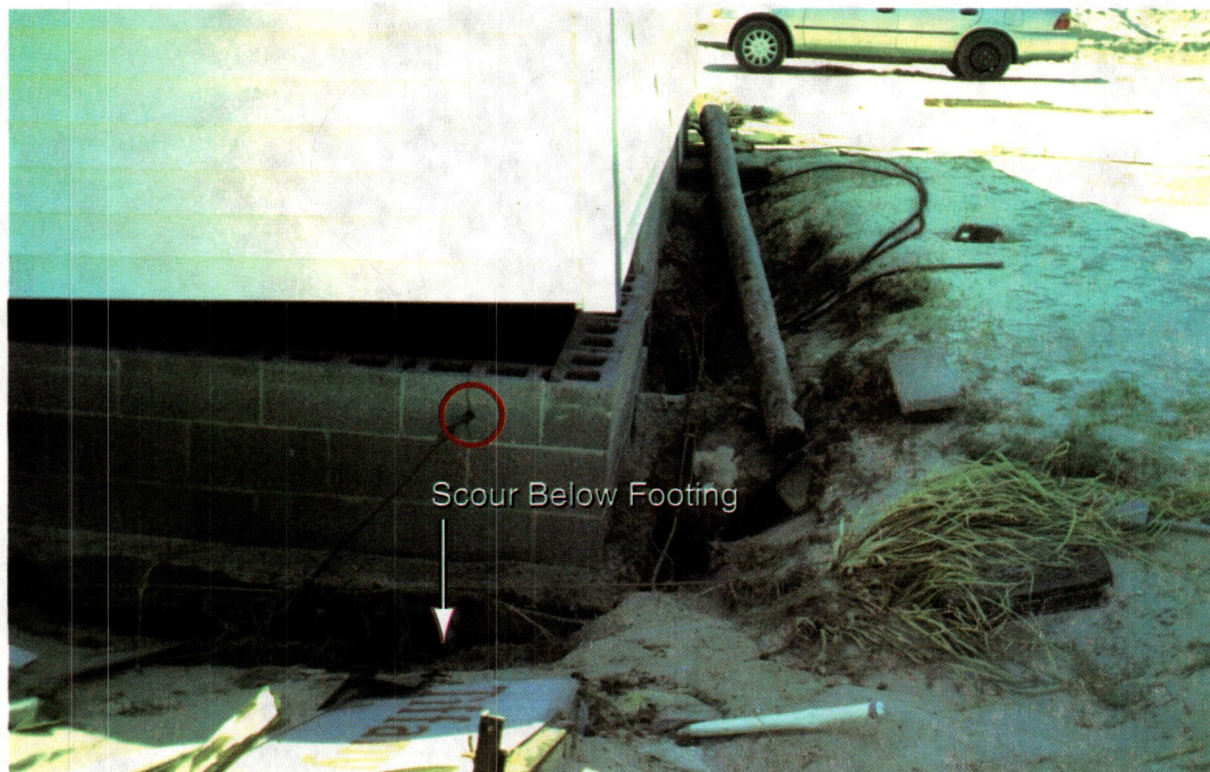
*Figure 2-22 Collapse of footing and foundation wall under elevated wood-frame building. Collapse resulted because obstruction of flow by building caused scour to extend below the bottom of the footing (arrow). Note propane gas line (circled) extending through foundation wall.*

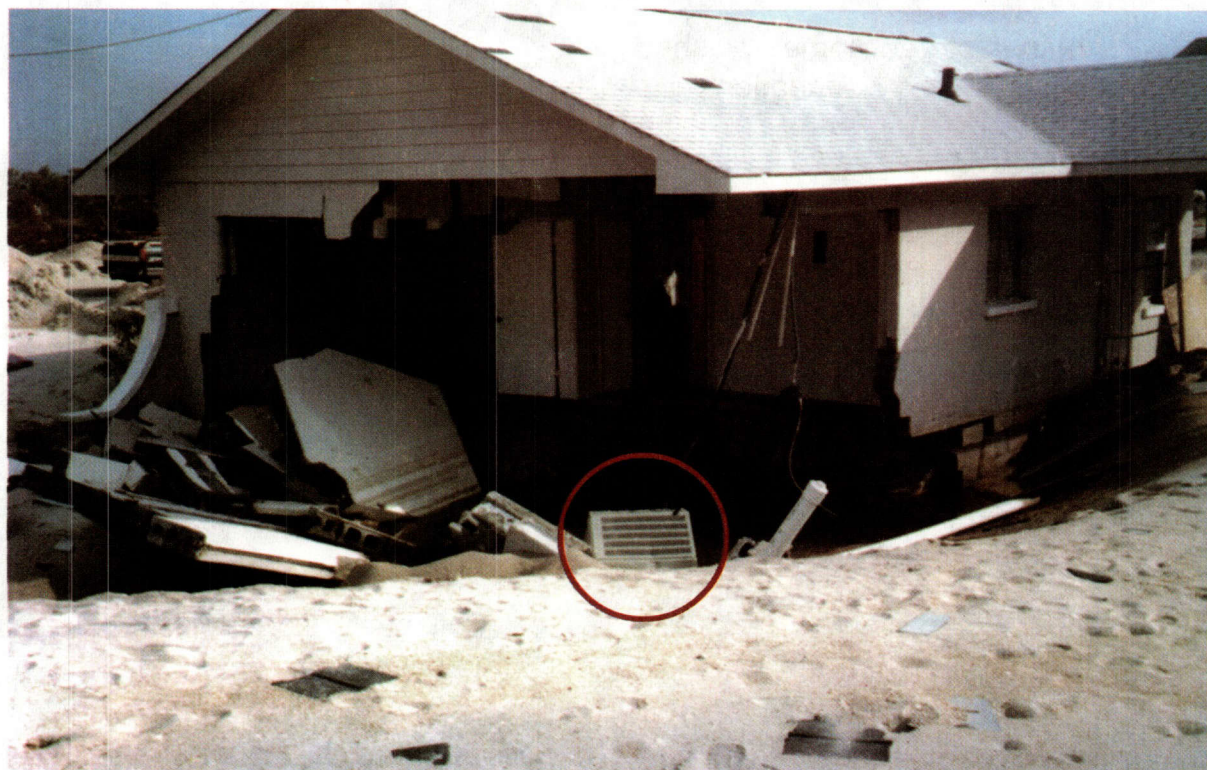
*Figure 2-23 Catastrophic failure of landward building constructed on masonry wall and slab-on-grade foundation. Failure resulted because obstruction of flow by building caused extensive scour. Note compressor collapsed into scour hole.*

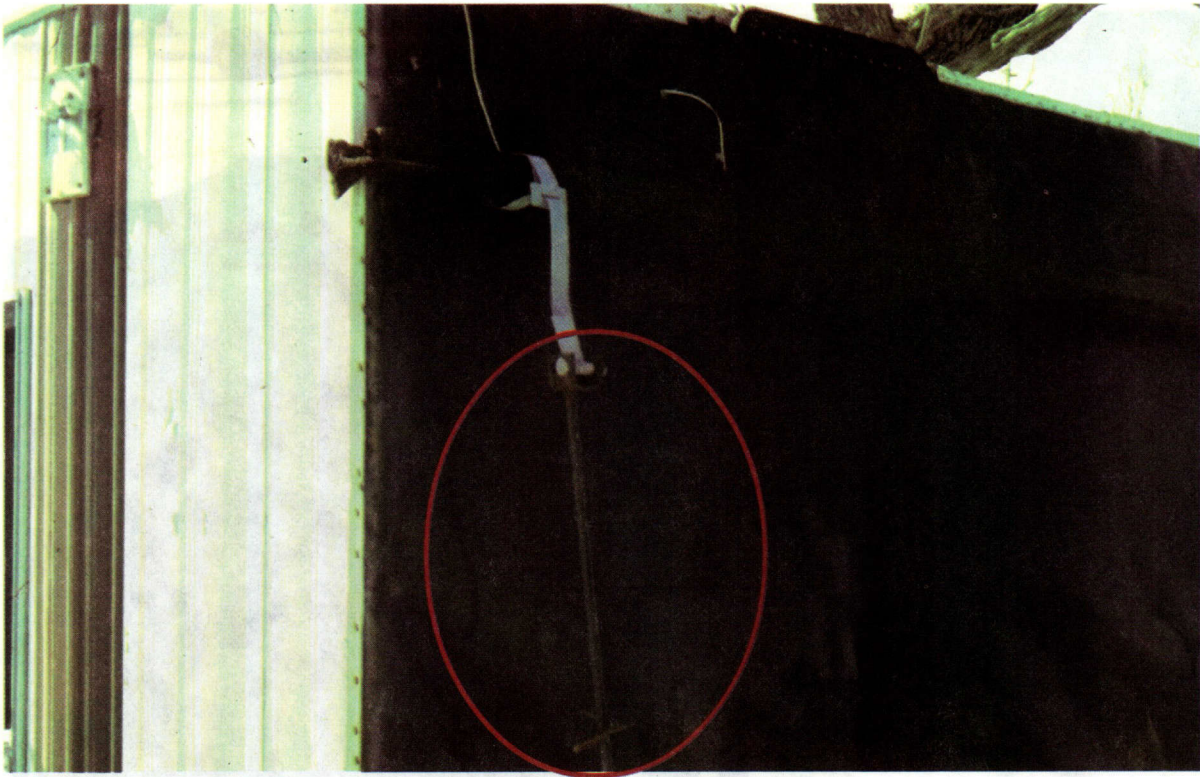
Figure 2-24 Permanently installed RV overturned as a result of anchor pullout. Anchor (circled) is 2 feet long.

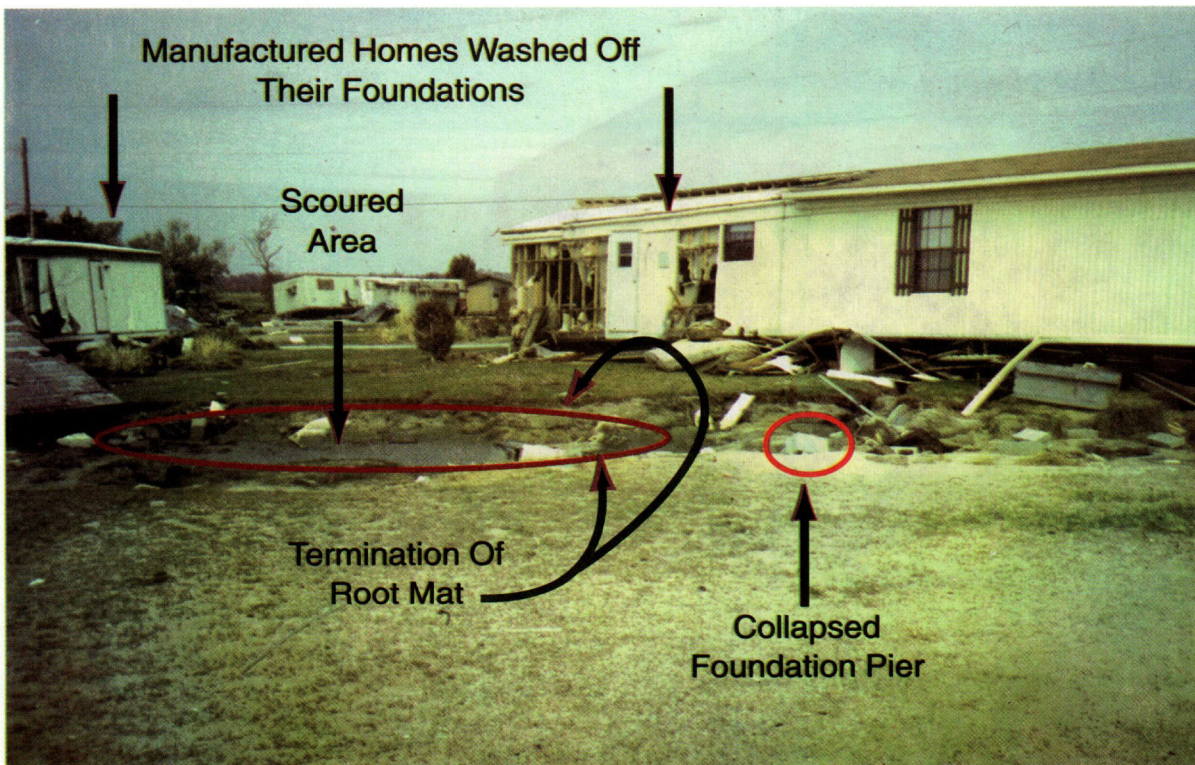
The team observed depressions from 1 to 2 feet deep left by localized scour within the original footprint of the structure (see Figure 2-25). The scour may have been caused by numerous factors, including a discontinuity between the stabilizing root mat provided by grass surrounding the site and the corresponding loss of unprotected sand beneath the home, the creation of a large obstruction by the solid skirt surrounding the foundation system, and localized scour around the dry-stack masonry piers supporting the structure.

Figure 2-25 Localized scour beneath pre-storm footprint of manufactured home. Note the collapsed dry-stack block foundation and termination of root mat, which otherwise would have helped stabilize the adjacent ground.

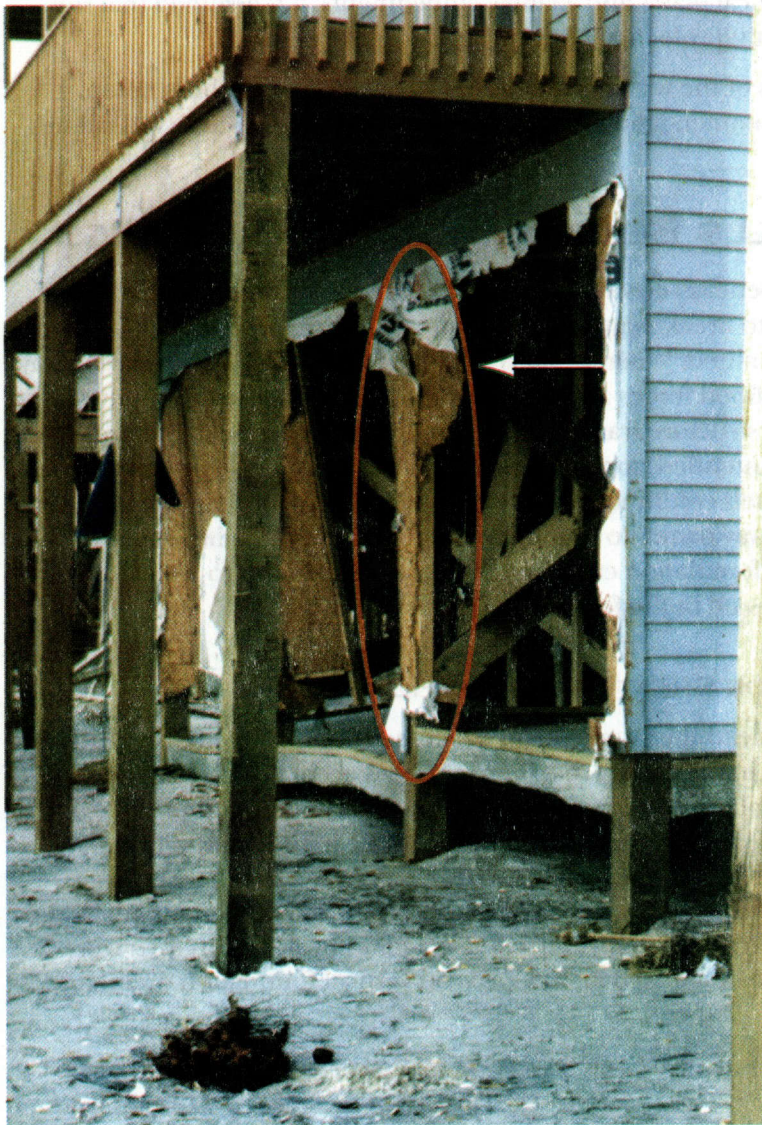
*Figure 2-26  
Exterior sheathing of breakaway  
wall spanned piling.  
Note torn sheathing (arrow).*

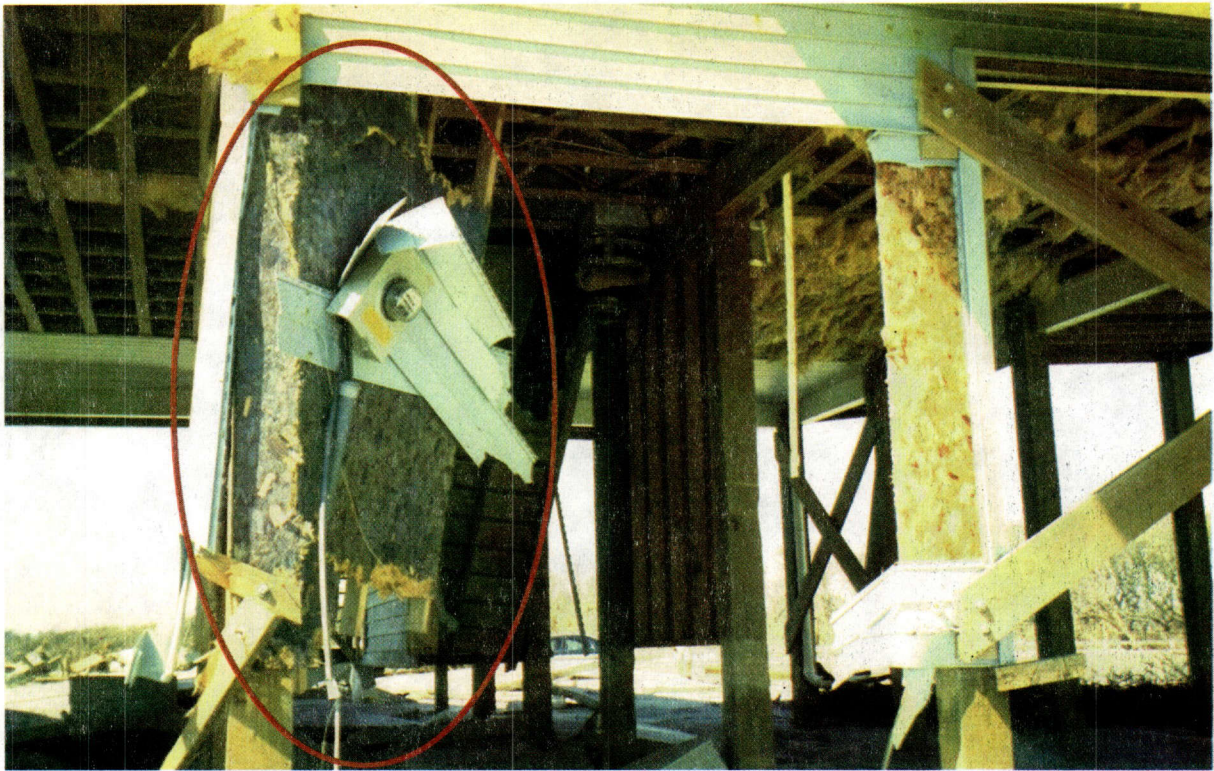
*Figure 2-27 Breakaway wall panel failed to function as designed because continuous sheathing was installed across pilings. No structural damage was observed; however, note damage to utility components installed on breakaway wall panel.*

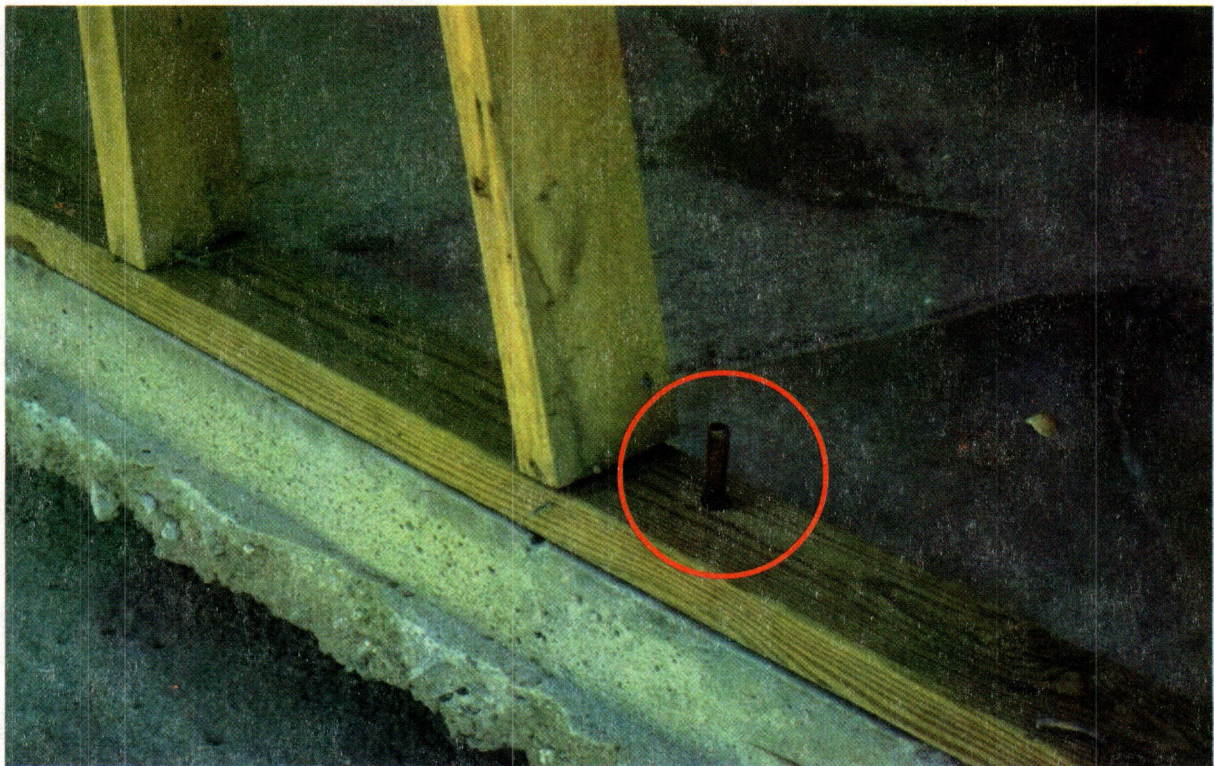
*Figure 2-28 Use of anchor bolts through the sill plate of a breakaway wall is improper. Even though this bolt does not have a nut and washer, it prevented the wall from breaking away laterally.*
